Race Rock Lighthouse  
Long Island Sound, New York  
**Report of Investigation**  
30 August 2019

**REPORT OF INVESTIGATION  
Race Rock Lighthouse**

Race Rock Reef, Long Island Sound, SW of Fishers Island, Suffolk County, New York  
WSA Ref No 1909.01

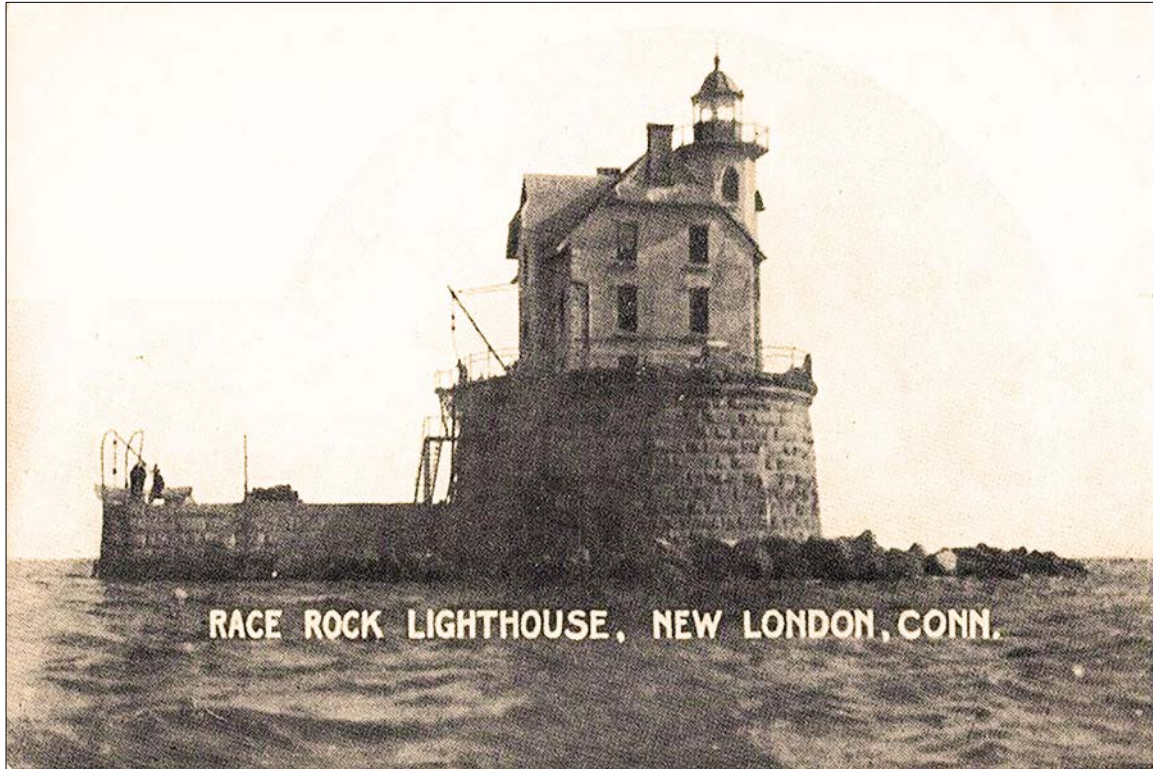
**Photo 1.** Race Rock Lighthouse is oriented roughly on ordinal points: its tower entrance faces generally southwest (SW). Note the original jetty/breakwater configuration in this pre-1915 image.

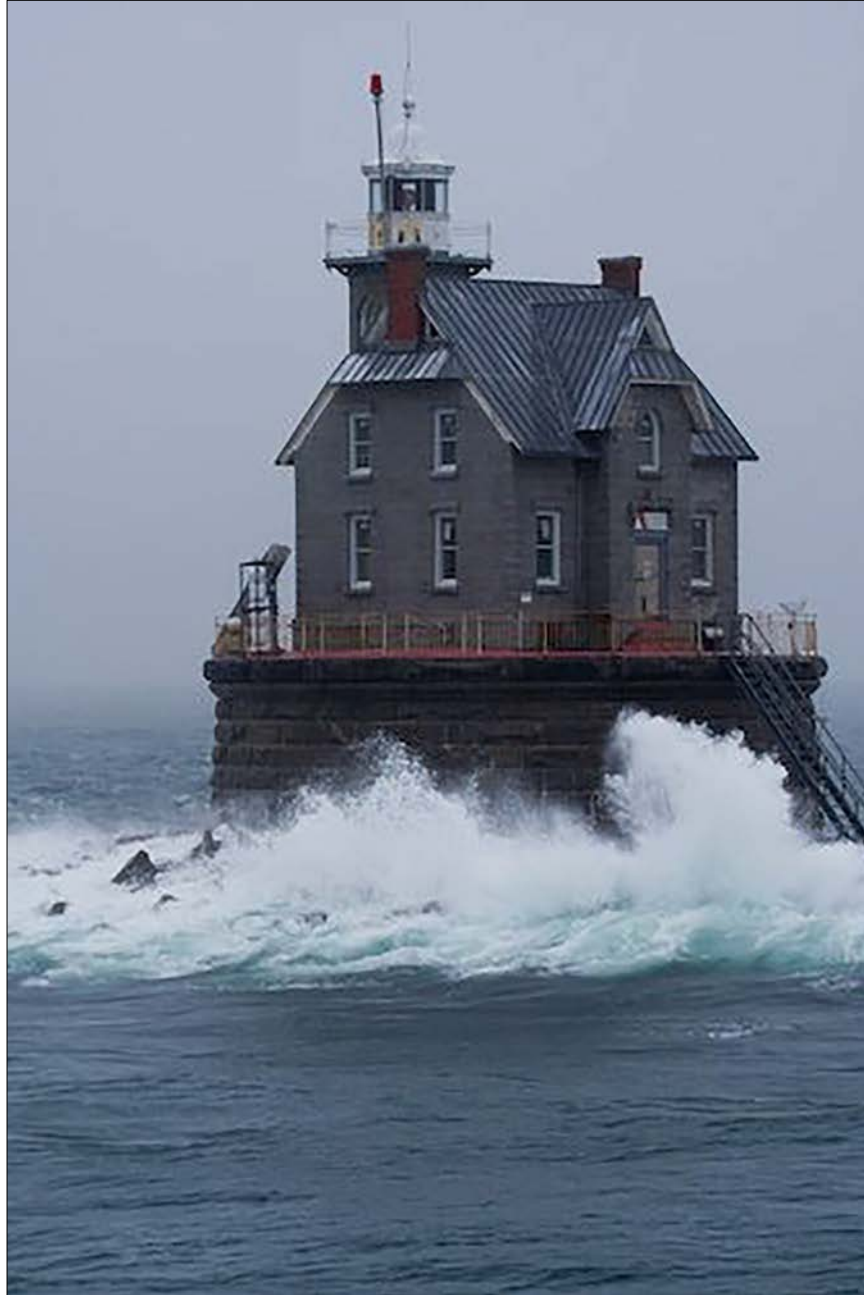
**Photo 2.** Wave action at high tide. Image credit: Rosario.

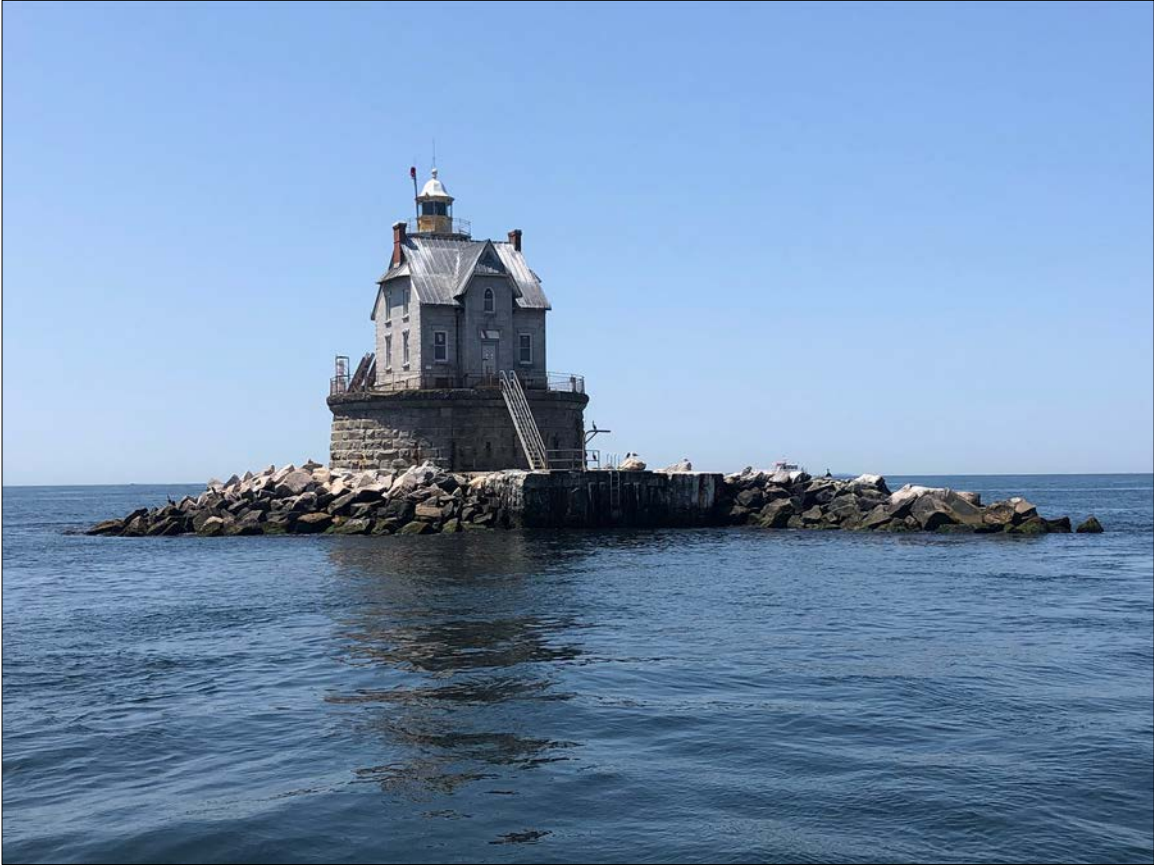
**Photo 3.** Approach to Race Rock Lighthouse, looking southwest. Landing poses difficulties.

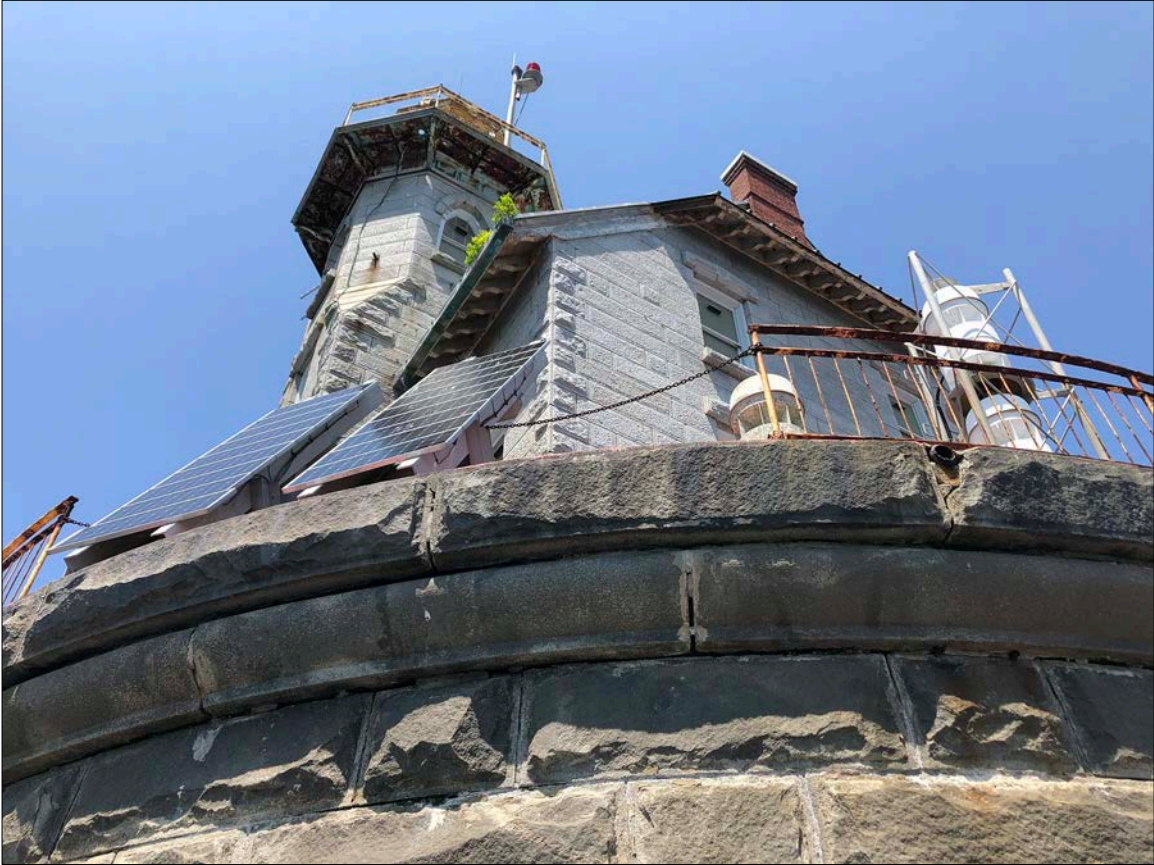
**Photo 6.** Missing rails, open masonry joints, gutters filled with organic matter, and similar myriad but addressable issues combine to undermine stability, even of structures built to last hundreds of years or more.

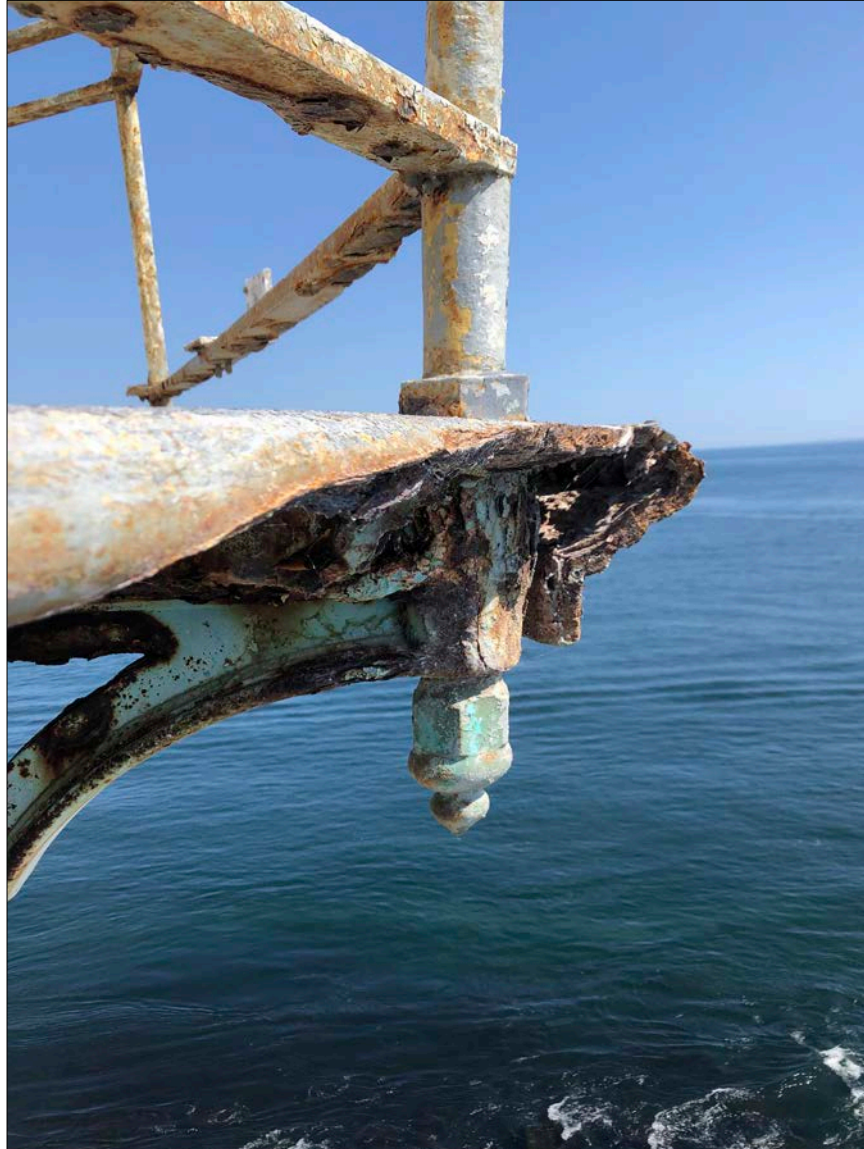
**Photo 13.** Detail of railing through-rod fastening assembly. Though severely corroded, missing elements may be restored by recasting in iron.

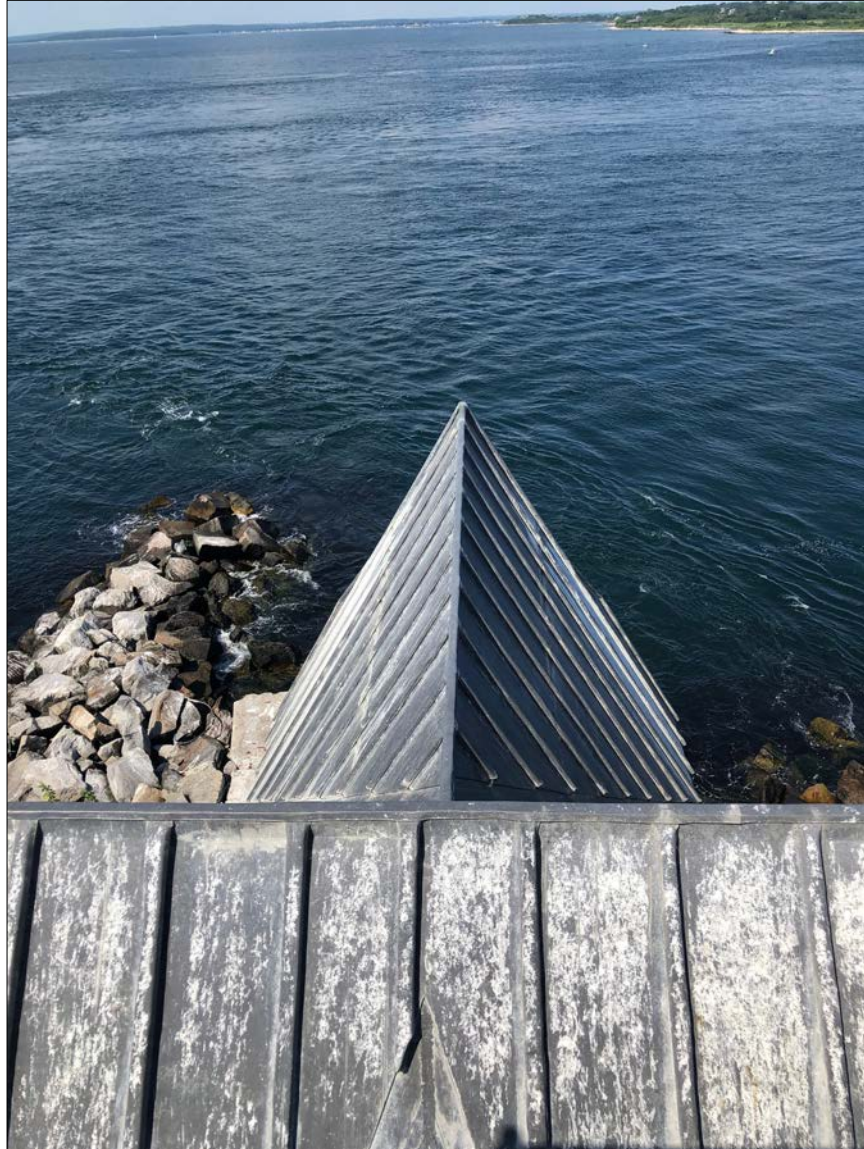
**Photo 15.** Present lead-coated copper batten roofing system is durable and appropriate, representing a significant sustainable component of the exterior envelope, and first line of defense for the Lighthouse proper (as the Drum deck is for the cellar stores below).

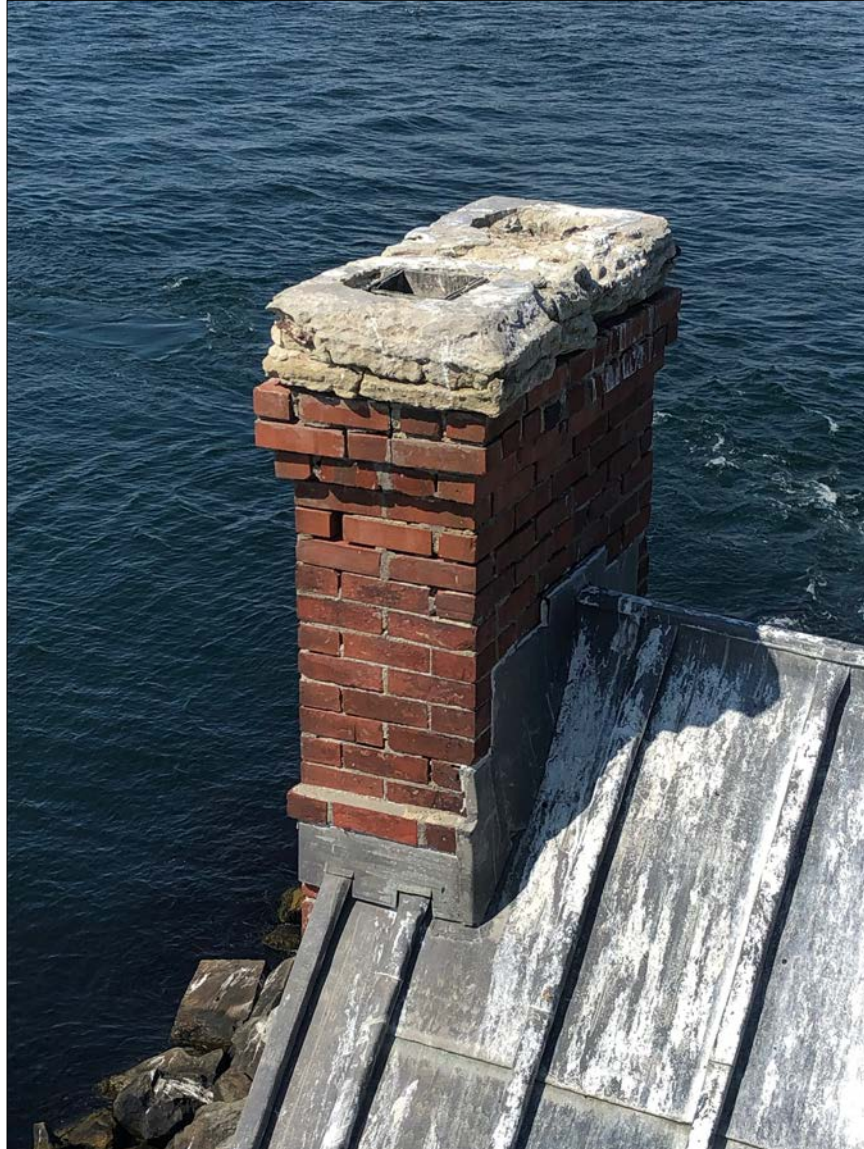
**Photo 16.** Despite the high quality of the present roofing installation, original chimney and other penetrations require special attention. Damage to the copings is not unusual, and eminently reparable.

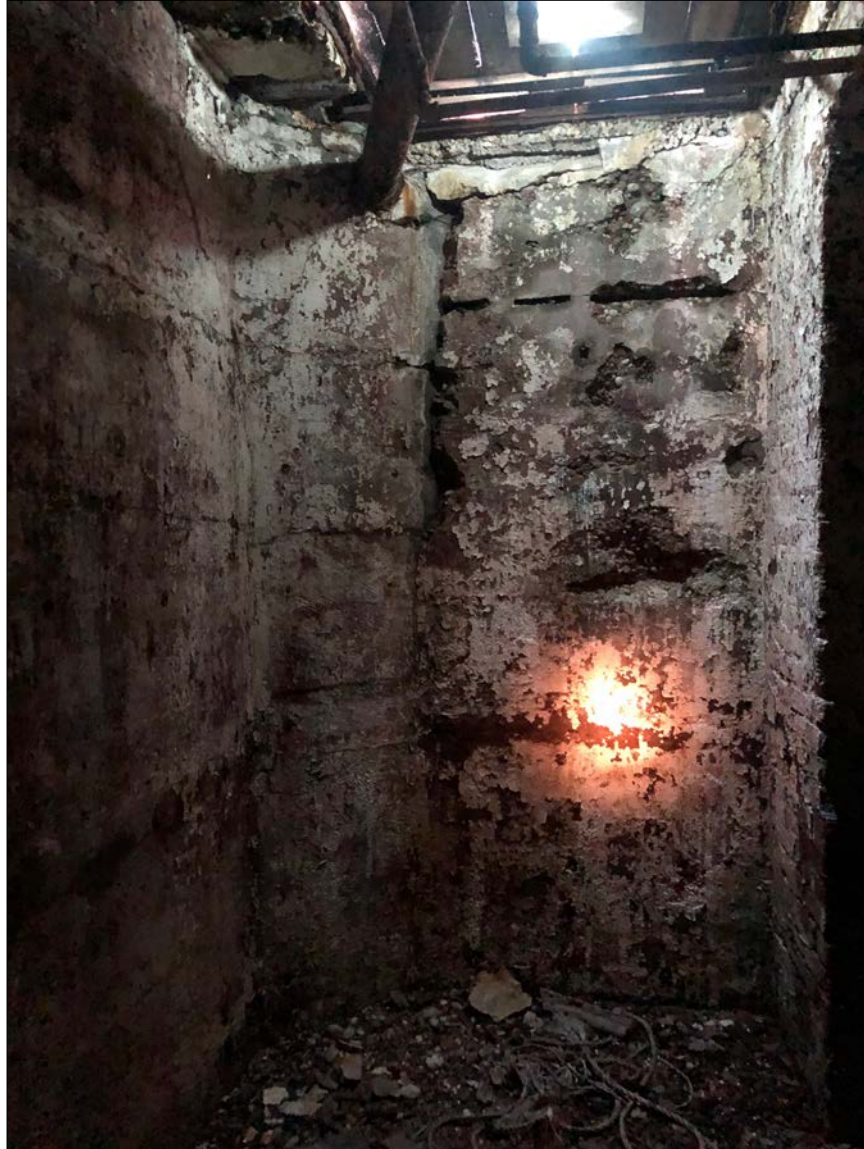
**Photo 17.** Beneath the Drum deck bulkheads are vertical access shafts for coal, food & ice. At present, these pose a severe potential safety hazard for anyone standing on or near the bulkhead plates, or below.

- 2.1. Both hatches leading from the drum deck to the Cellar are disguised, albeit also roped off to deter stepping on them. While these important access links need to remain, they also require re-structuring to keep a person from inadvertently falling through them.

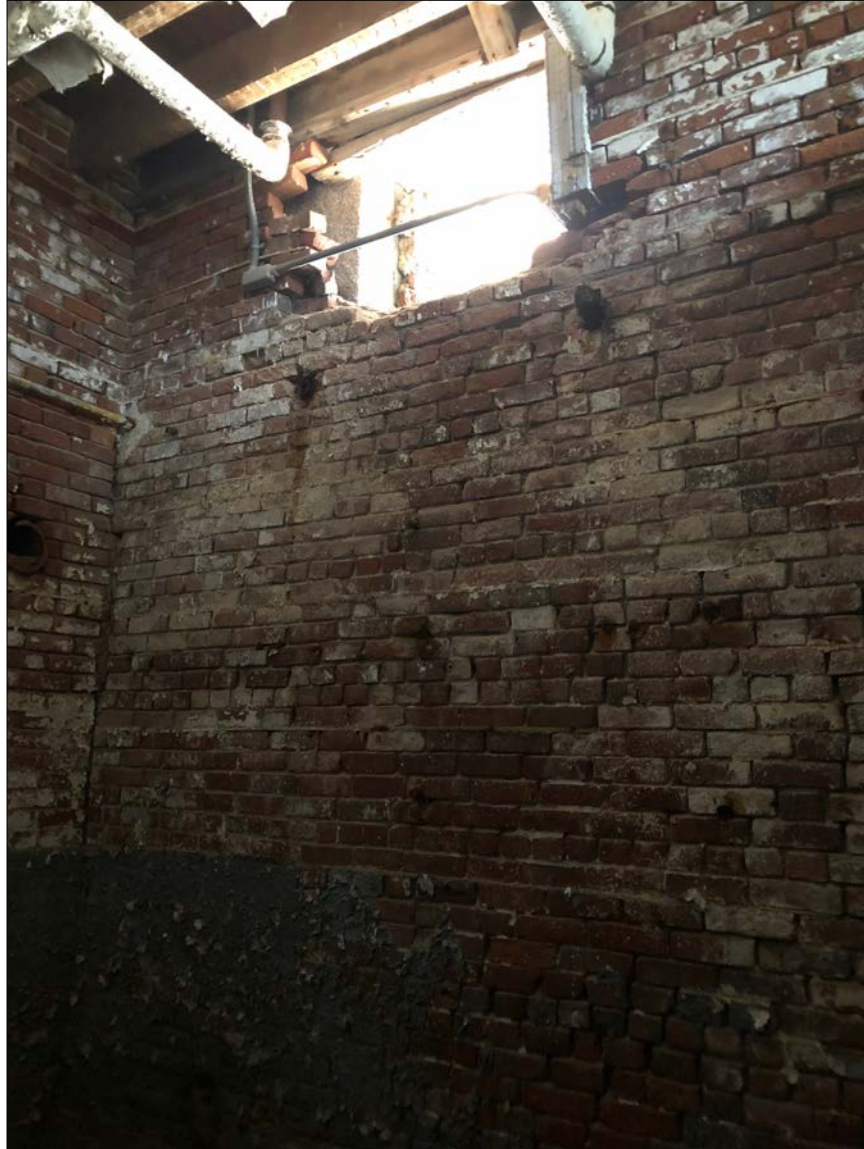
**Photo 18.** The cellar level within the Drum housed a variety of functions critical to Keeper & family, primarily related to food, water and heating. It is punctuated with upper windows at the level of the Drum deck for ventilation and light. Efflorescence of embedded salts is evident in the brick walls.

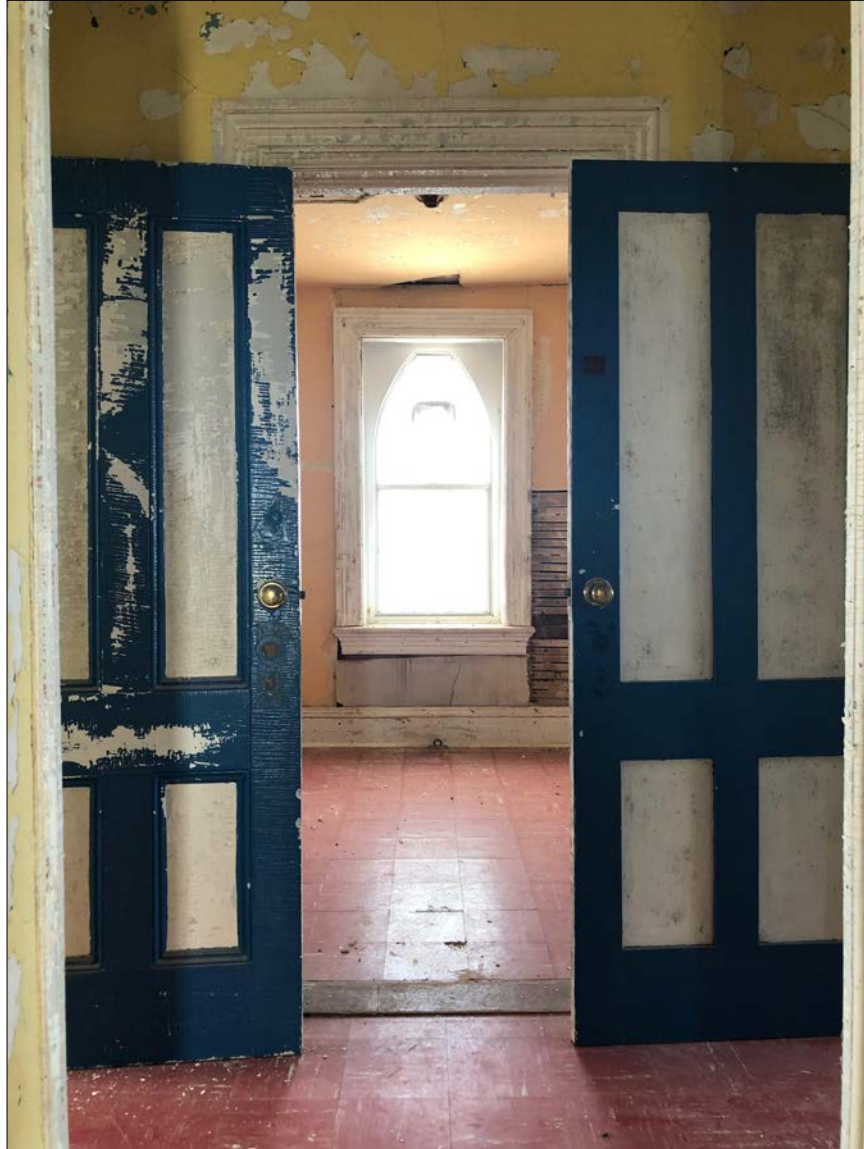
**Photo 19.** Interior spaces are largely intact, with many features displaying a multitude of changes over time. Understanding the value of each element as an artifact is crucial before any restorative work is begun.

- 6.1. While it may be tempting to “clean up” spaces during the application of the above recommended stabilization measures, it is recommended that ALL MATERIALS BE LEFT IN PLACE, UNDISTURBED. Even seemingly innocuous elements provide vital clues during restoration planning and implementation. More important, we already have discovered a treasure trove of original elements strewn across many interior spaces, from Cellar to Attic. The time will come to properly catalog and analyze all of these remnant artifacts.

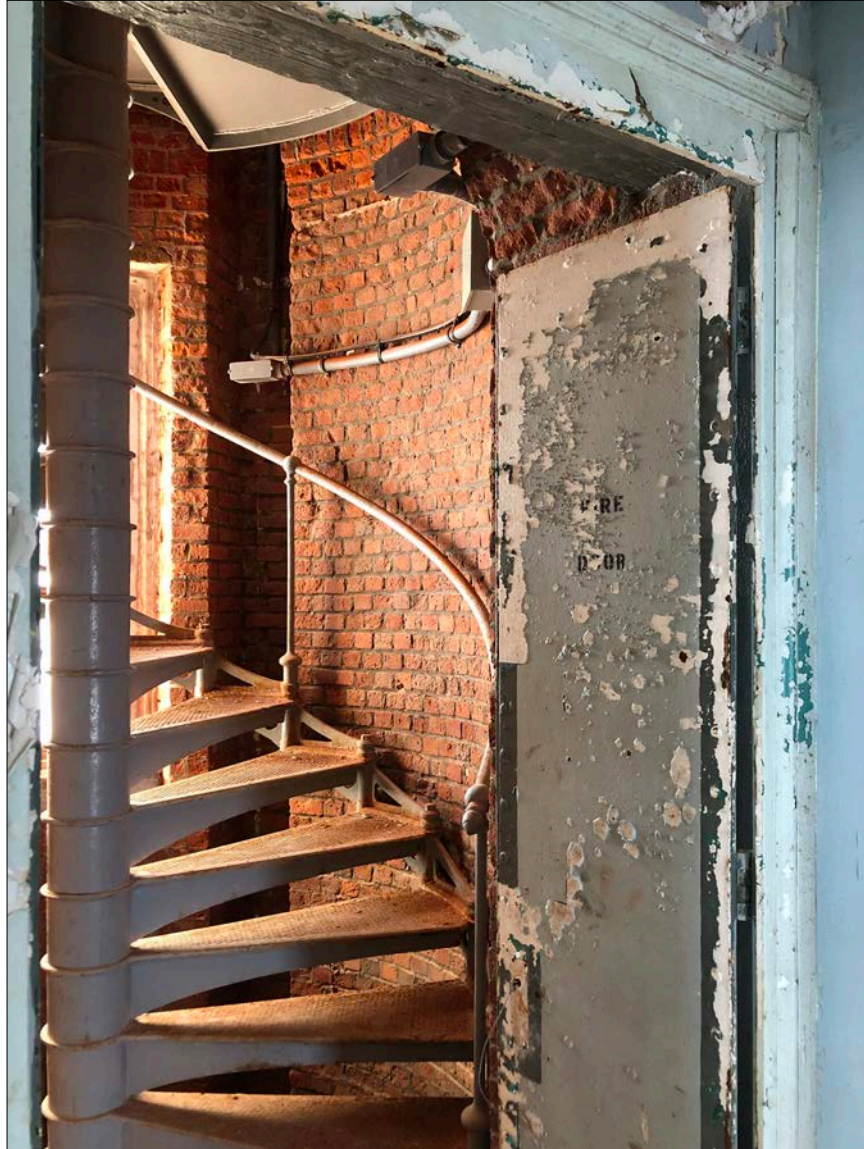
6.4. Deterioration of the interior brick of the tower stairwell is characteristic of the type of extensive damage that is often the response to layers of inappropriate interventions:

- Originating with the cast iron lantern gallery decking, lack of ongoing maintenance led to rusting that, in turn, invited “rust-jacking,” literally applying microscopic but highly intense pressures to the cast iron elements;

- In response, the cast iron plates shift or – worse – crack (both have occurred);
- More water gets in, reaching the stone below the deck;
- Mortar erodes, remains unaddressed, and ultimately more water is allowed to seep into mortar joints (both vertical and horizontal);

- Because of the massive inherent compressive strength of granite, when the water within joints freezes and expands, it moves the stones apart (i.e., they tend to not crack) and water reaches the interior;

- The collar joint between the exterior stone wall and the interior brick facing – often irregular by nature – allows water to spread widely behind the brick surfaces, where it is slowly absorbed by the brick;

- As the imbedded water begins to evaporate, it tends to favor warmer (i.e., interior) surfaces, expressing itself as dampness across the exposed brick surfaces;

- Once water begins to evaporate, it leaves behind particles of dissolved salts that have been collected from the atmosphere and its travels within the Light Station’s wall system, forming whitish blotches on the interior exposed brick surfaces;

- In reaction, the interior brick joints are aggressively pointed with a “hard” mortar;
- Hard mortars force water through the brick rather than – as intended – through the previously (and originally) more permeable joints, exacerbating the dampness and efflorescence and, in turn, deteriorating the brick itself (it begins to “sugar” as particles of brick are dislodged during the evaporation & salt deposition process;

- Harder, and more, mortar worsens and accelerates the condition, until additional remedies are sought; and, finally
- Coatings are applied, which likely will lead to the complete destruction of the wall.

**Photo 21.** Vertical circulation plays a multiple role: fire egress, convective air flow (for the wick of the original lantern, plus expulsion of warmed air during summer months that helps keep the interior relatively cool. Water ingress through the Lantern above has seeped into brick walls; evidence of brick dust is everywhere, indicating a deep process of degradation.

6.5. This process can be properly resolved by addressing the source of the problem: unpainted, and now deteriorated, cast iron exterior plates. Keeping water from getting in is the key to success for remediation/restoration programs treating water ingress.

- 2.1. DO NOT apply any coatings or other products to the interior surfaces of the brick!
- 2.2. Provide a secure weatherproofing system that encompasses the entirety of the Lantern gallery decking, down to the base of the octagonal portion of the stone tower below (approximately 8'-10' vertically). Allow the masonry materials within this enclosure to dry out naturally before next steps are taken; this will require at least 3-4 months, and may readily be monitored with field meters as desired. Once excessive moisture levels have stabilized, durable corrective measures may begin.

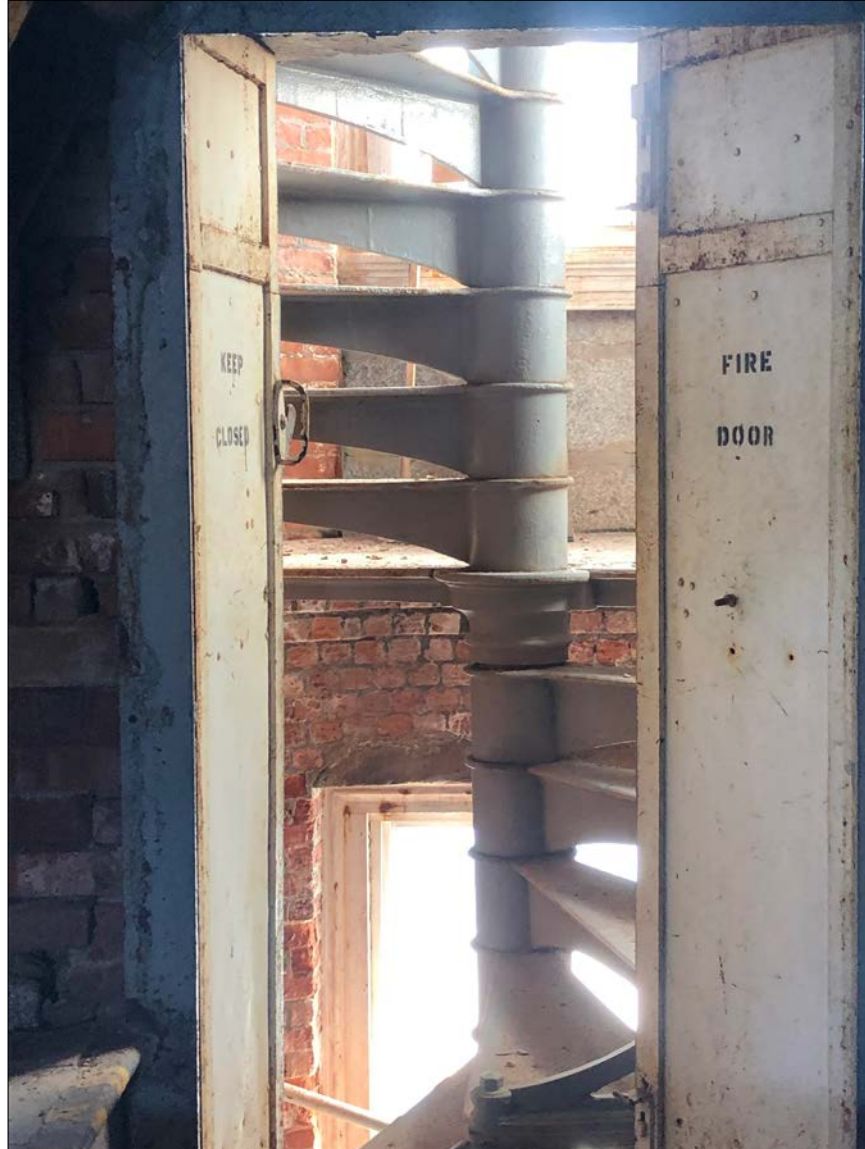
**Photo 22.** Cast iron spiral stairs continue directly to the Lantern, via the attic and Service Level of the Lighthouse. Water seeping through the Lantern's cast iron elements is evident throughout.

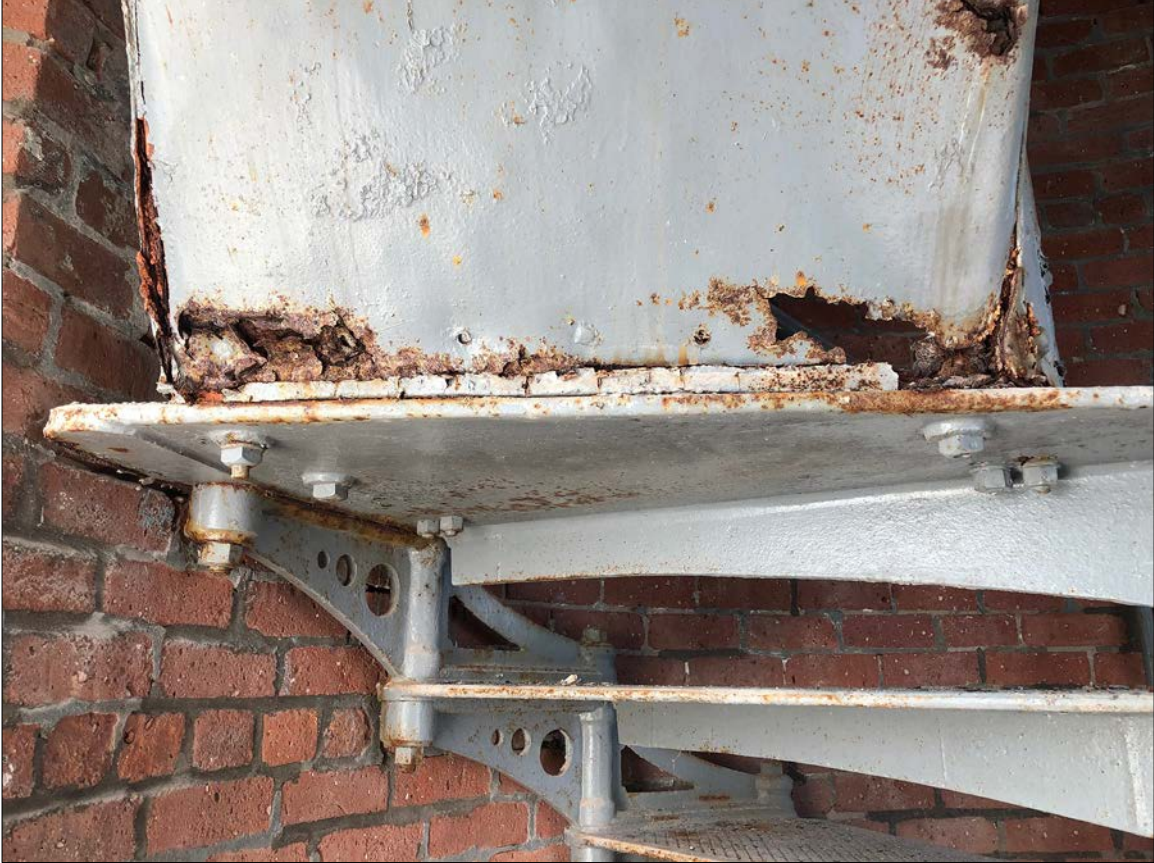
**Photo 23.** Just beneath the Lantern Level, the final stair run is permeated with rust resulting from water ingress above as well as deposition of condensation from being closed for long periods. Despite its appearance, damage such as this remains very restorable.
