Race Rock Lighthouse  
Long Island Sound, New York  
**Report of Investigation**  
30 August 2019

**REPORT OF INVESTIGATION  
Race Rock Lighthouse**

Race Rock Reef, Long Island Sound, SW of Fishers Island, Suffolk County, New York  
WSA Ref No 1909.01

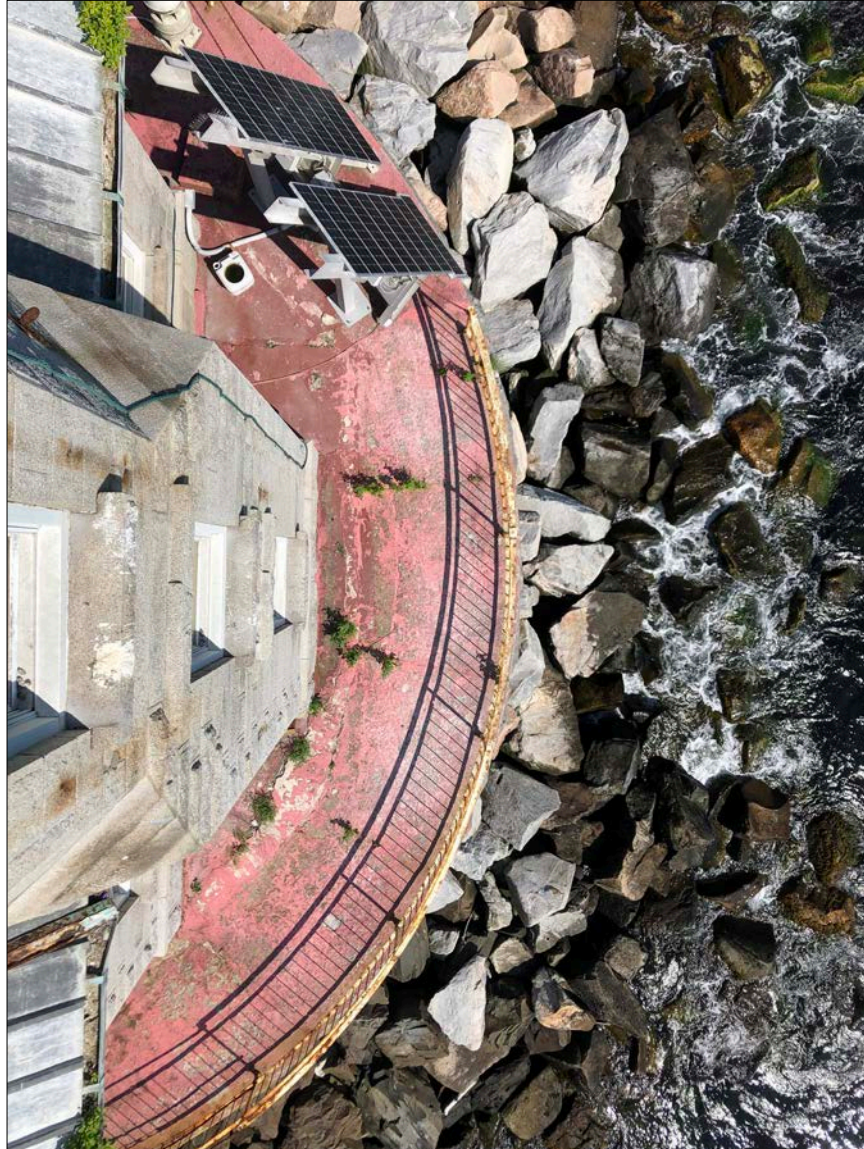
**Photo 7.** View from the Lantern Gallery to the drum, deck & riprap below.
